NASA TECHNICAL MEMORANDUM

BONDED COMPOSITE-TO-METAL SCARF JOINT PERFORMANCE IN AN AIRCRAFT LANDING GEAR DRAG STRUT

by William E. Howell

Langley Research Center
Hampton, Virginia

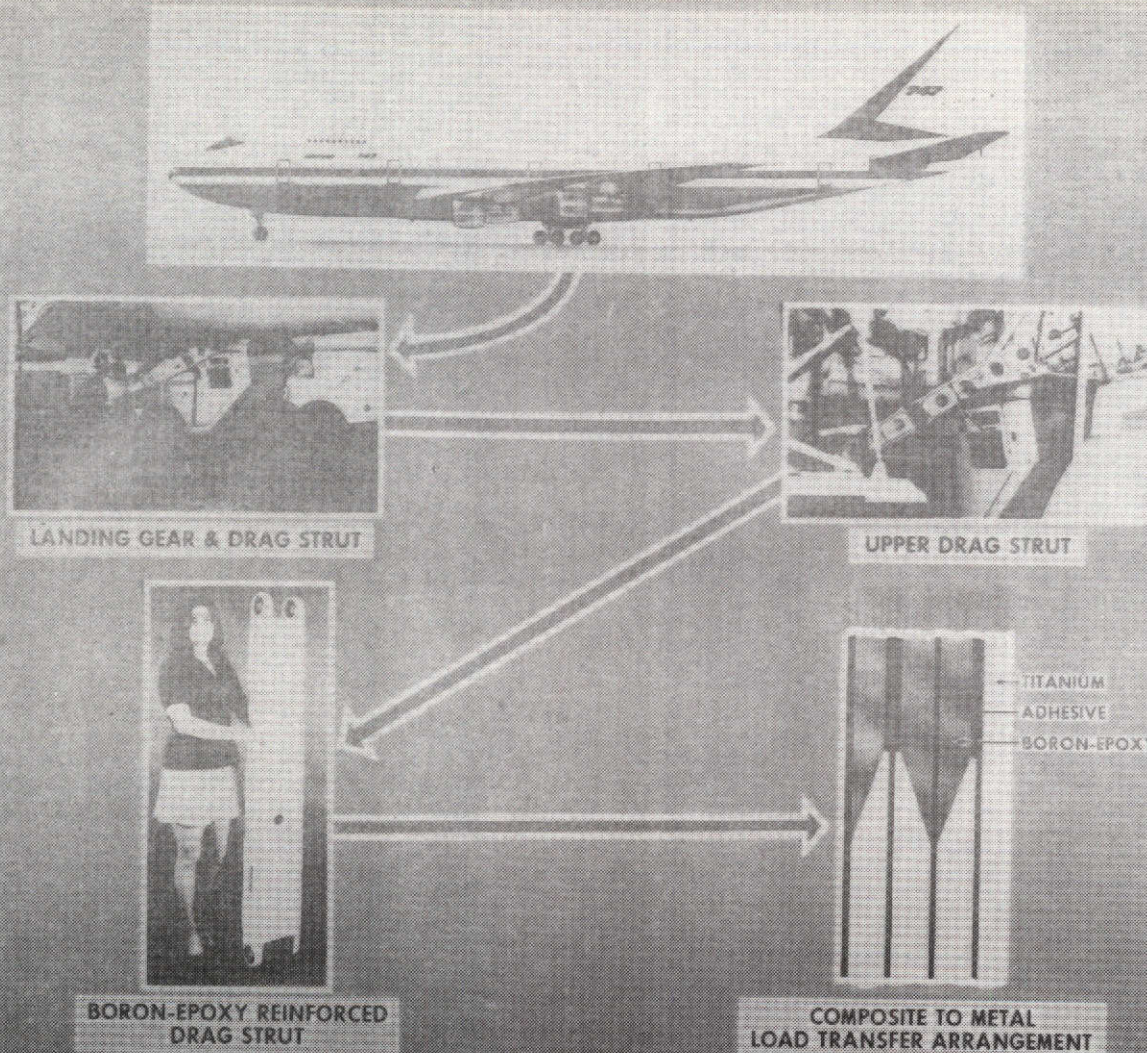
Figure 1. - Composite reinforced drag strut for the Boeing 747 transport.

(ref. 1) were used in the design in a manner to satisfy the performance specifications of the main body landing gear of the Boeing 747 transport aircraft (Fig. 1). Details of the strut are shown in figure 2. Except for the ends, where the strut is entirely laminated titanium, unidirectional boron-epoxy was used to stiffen the thin titanium cover skins and provides 80 percent of the load carrying capabilities of the strut. A titanium strap which had a uniform $0.017 \text{ rad. } (1^\circ)$ tapered scarf and a 16-ply boron-epoxy strap in which the plies terminated at 1.02 cm (0.4 in.) steps were bonded together in a co-cured process. Eight of these straps were secondary-bonded together to form the complete load carrying portion of the flanges. (See figure 2b))

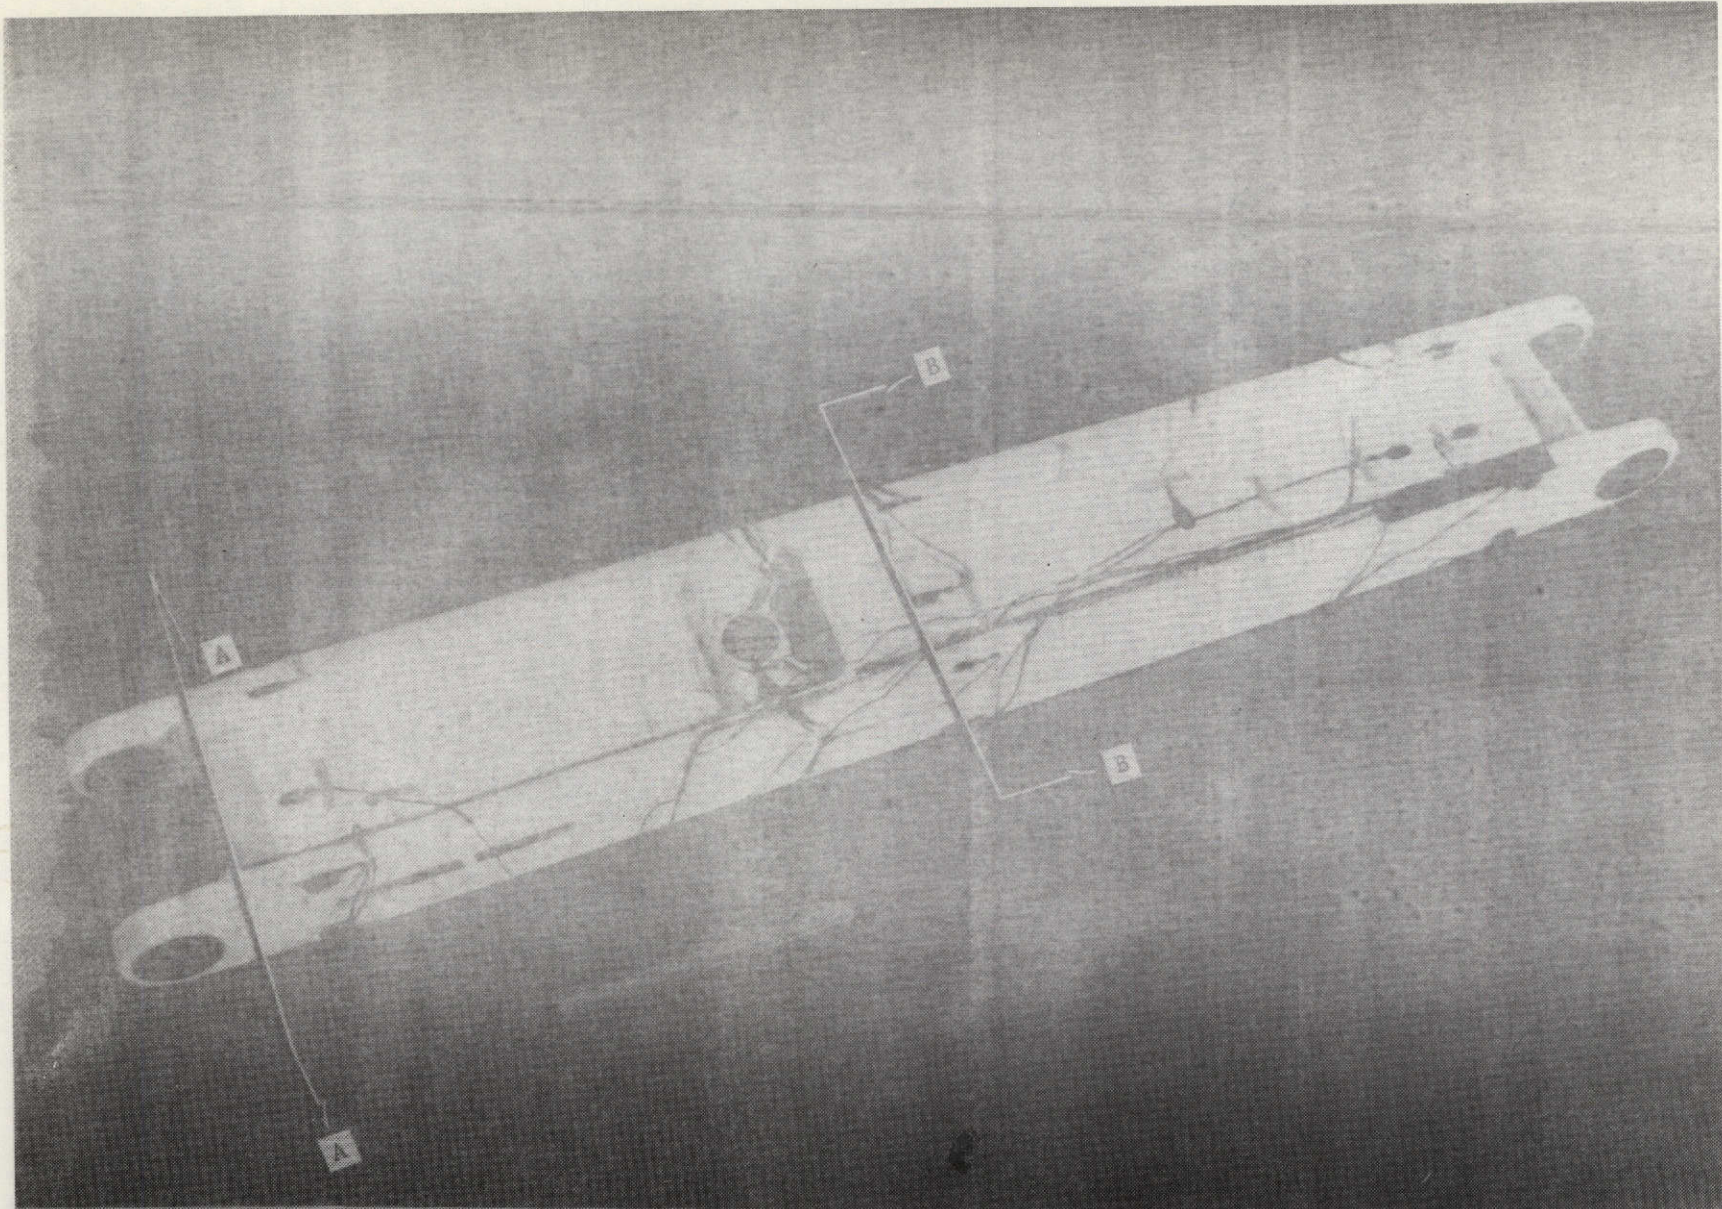
Figure 2a. - Detailed view of drag strut showing locations of view A-A (fig. 2b) and section B-B (fig. 2c).

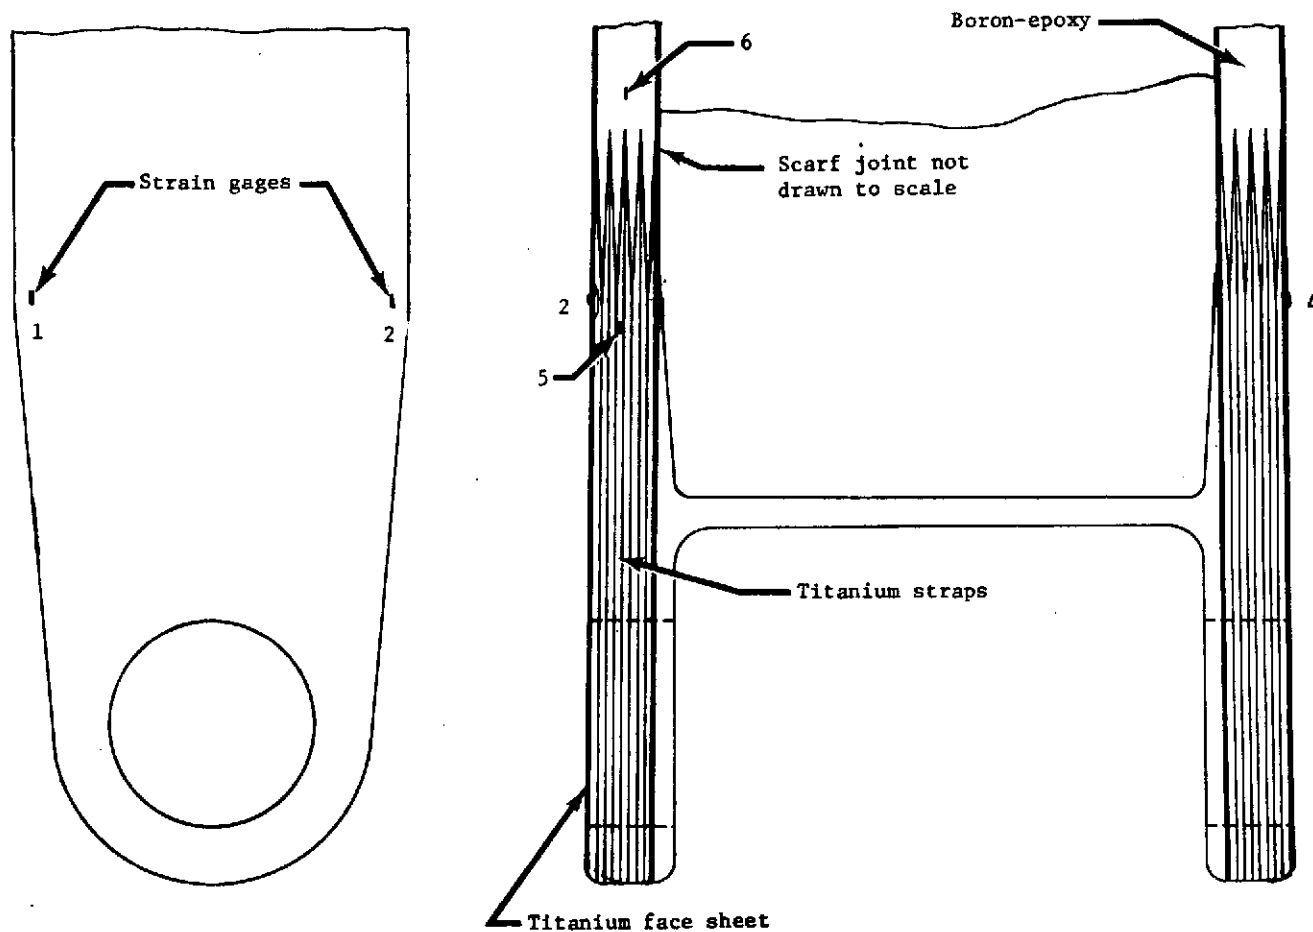
Figure 2b.- Strain gage locations at the boron-epoxy-titanium joints near the ends of the drag strut.

The behavior of the drag strut during these tests was monitored by strain gages located on the flanges in the vicinity of the bonded joints as shown in figure 2b, as well as at a number of other locations.

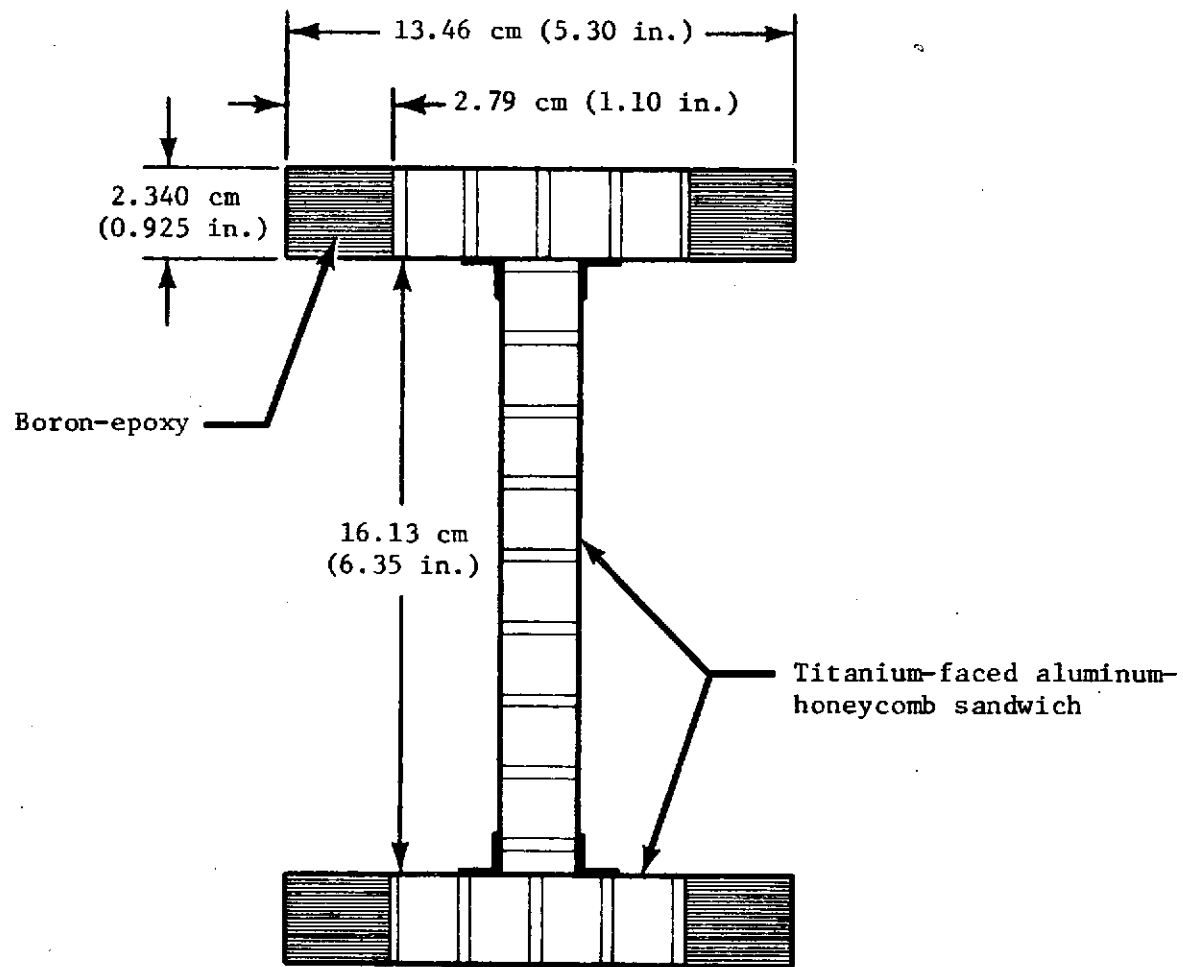
Figure 2c.- Drag strut cross-section at section B-B.

Figure 2c is a cross-sectional view of the I-beam configured strut and shows the boron-epoxy reinforcement at the extremities of the flanges. The remainder of the strut was fabricated of titanium faced aluminum honeycomb-core sandwich. No mechanical fasteners were used; the entire strut was adhesively bonded together. The total mass of the completed strut is 34.5 kg (76 lbs), 30 percent less than the production drag strut.

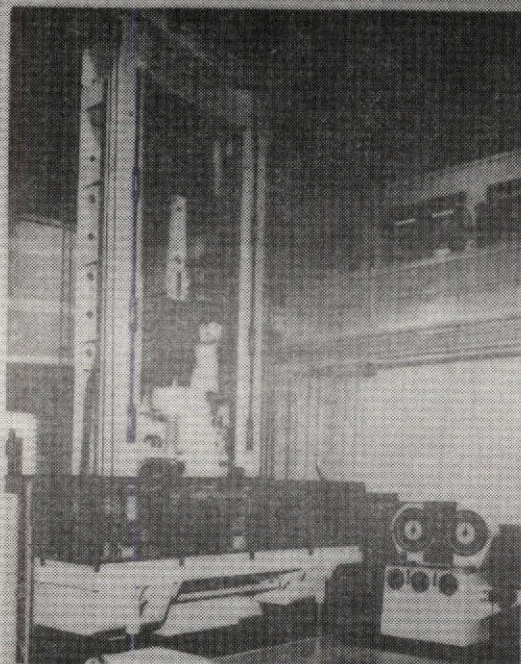
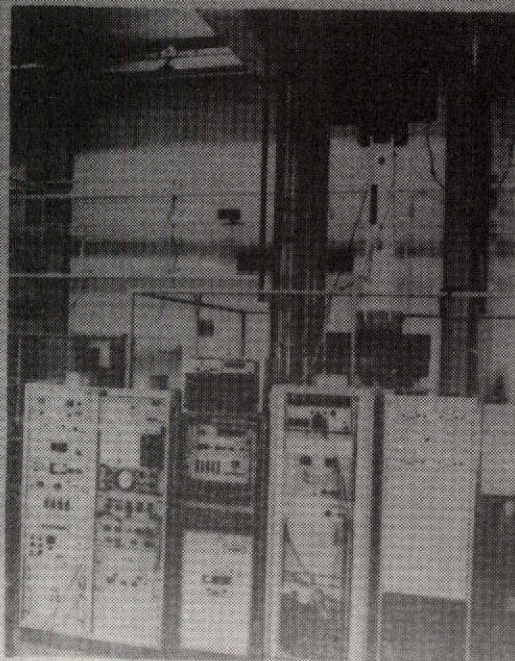
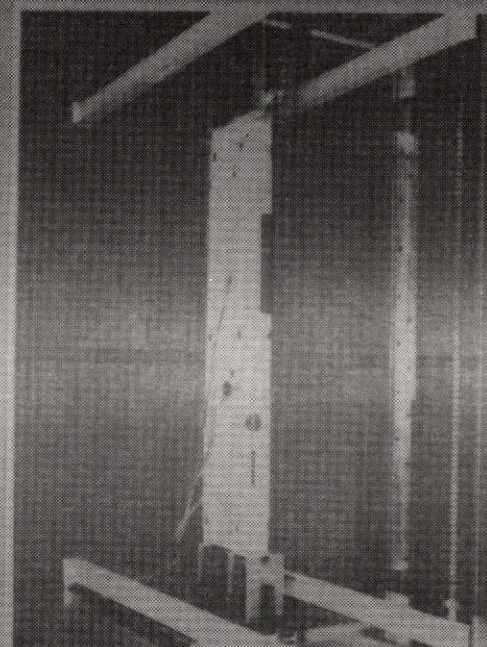
TENSILE TEST

FATIGUE TEST

COMPRESSION TEST

Figure 3. - Experimental test arrangements for composite reinforced drag strut.

The experimental evaluation of the drag strut was conducted at the NASA-Langley Research Center. Three different tests were performed on the drag strut: fatigue test, static tension test to the design ultimate load, and static compression test to the design ultimate load. (See fig. 3.)

After the fatigue test was completed, the drag strut was mounted in the 5.34 MN (1,200 kips) capacity static testing machine (fig. 3) and was loaded in tension to the design ultimate load of 1.65 MN (372 kips). Figure 6 is a plot of some of the strain gage data as a function of applied load. The measured strain from the four gages positioned over the end of the first ply of boron-epoxy (gages 1, 2, 3 and 4 in fig. 2) indicates that the strut behaved in a linear manner. Maximum strain in boron-epoxy sections was approximately 0.0038 at the tensile design ultimate load. There was no indication of any damage due to the loading.

Following the tensile test the strut was mounted in the compression side of the 5.34 MN (1,200 kips) capacity static testing machine (fig. 3) and loaded to the compression design ultimate load of 2.83 MN (636 kips). Figure 7 is a plot of the compression data obtained from strain gages 1, 2, 3, and 4 shown in figure 2. Maximum strain at the compression design ultimate load was approximately 0.0060 in the boron-epoxy sections. Again, the data indicate that the strut behaved in a linear manner and survived the load with no apparent damage.

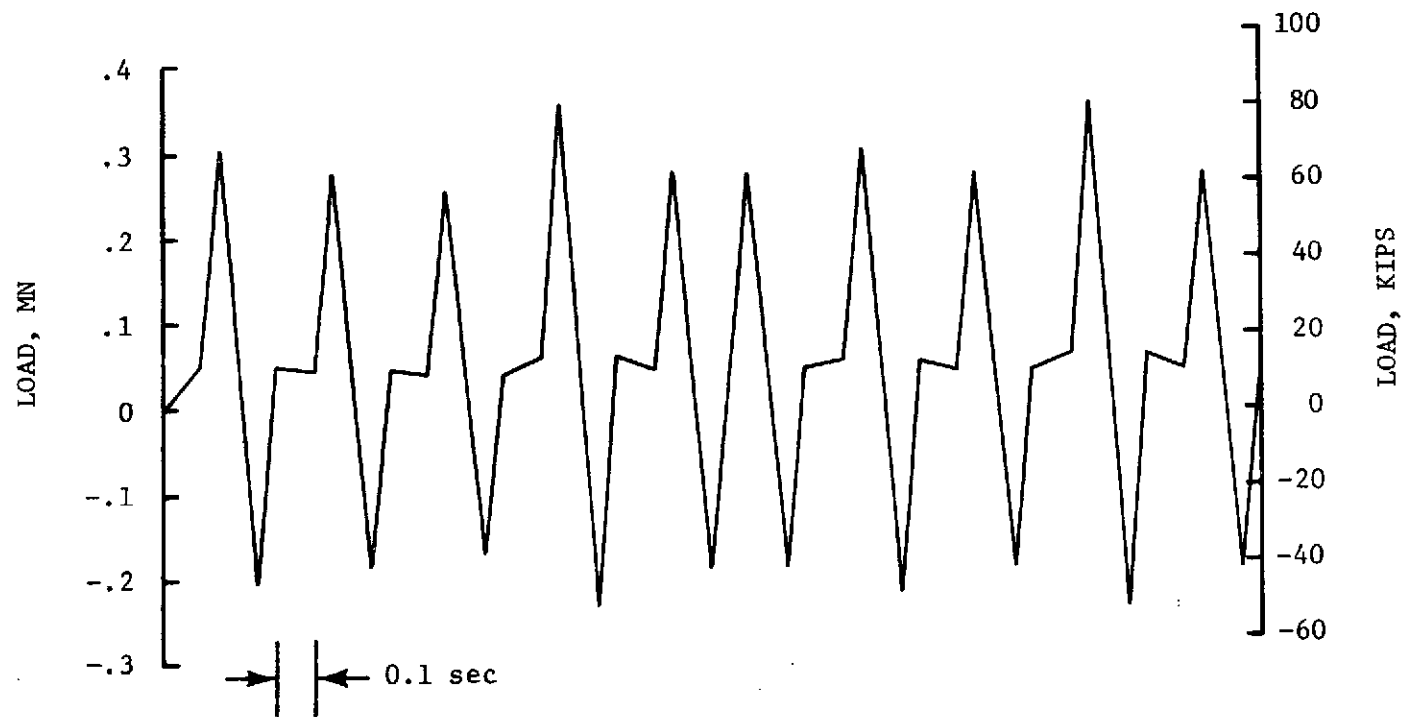
Figure 4.- Sample of the fatigue load spectrum.

The drag strut was exposed to two lifetimes of spectrum loading in the 1.78 MN (400 kip) capacity fatigue test machine. A sample of the spectrum is shown in figure 4. This spectrum is associated with training flights, 1-hour flights, 3-hour flights, and 7-hour flights. Each of the four types of flights has distinct mean and alternating loads. The load spectrum consisted of these four different load levels randomly arranged in a block of 33 cycles. This block of loading was applied repeatedly until two lifetimes of loading (198,000 cycles) were accumulated. The cyclic load was applied at a rate of 5 Hz. No hysteresis heating was detected. The peak load in the spectrum, 355 kN (79,800 lbs) in tension, which is only 22 percent of the design ultimate load was applied once every 100 blocks of loading for a strain survey. These data were used to monitor any changes which might occur in the strut due to the cyclic loading. A sample of these data are shown in figure 5 where strain is plotted as a function of the number of cycles of loading and shows no significant change in the strain during the test. The small, random variation is believed to have been caused by ambient temperature changes during the test.

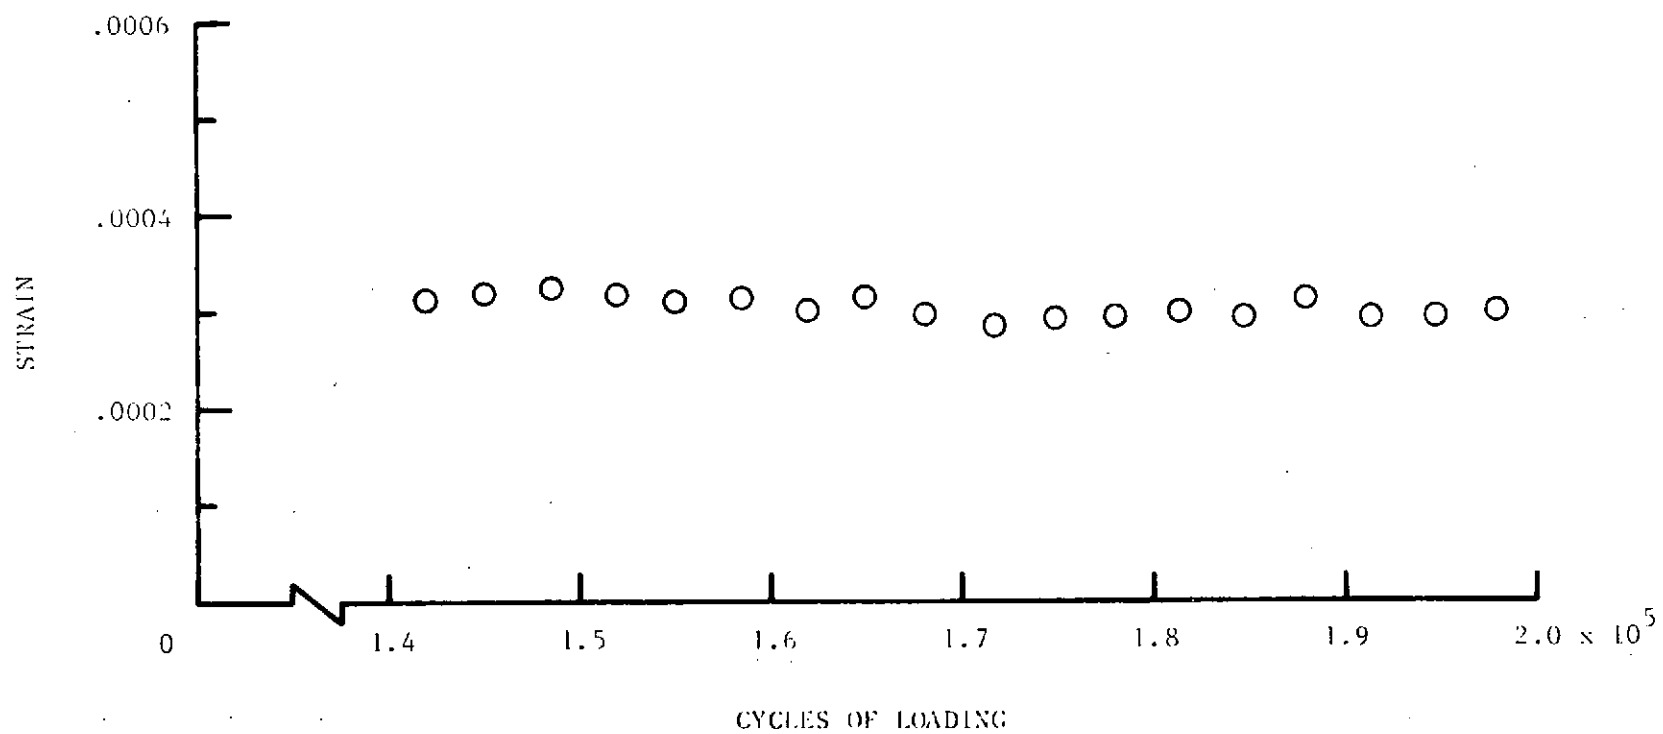
Figure 5.- Strain gage data from fatigue test (one location).

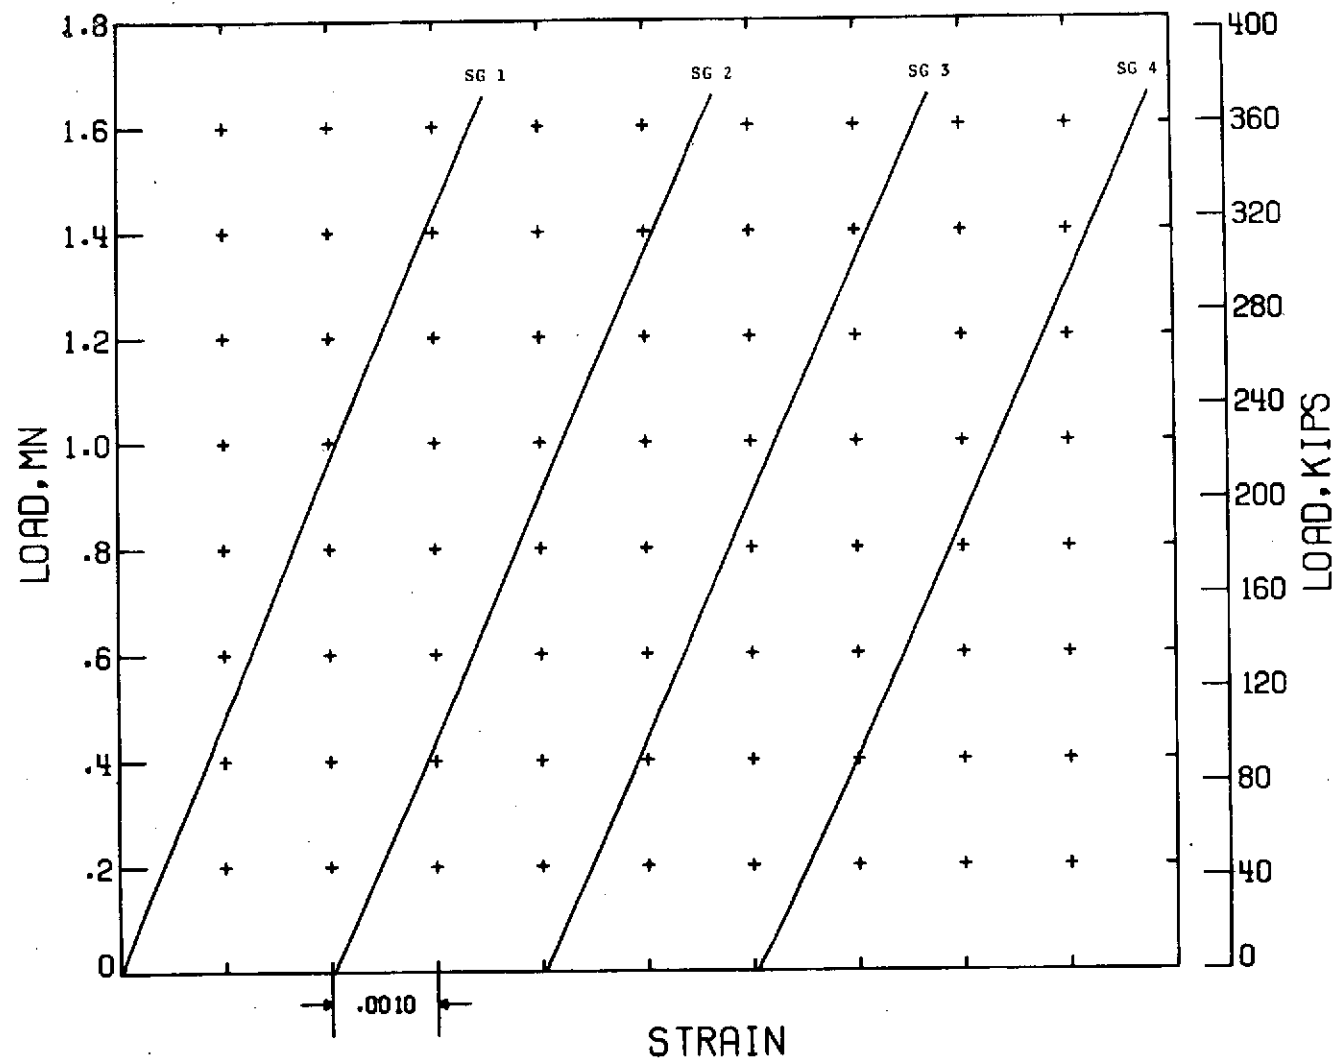
Figure 6.- Strain-gage data for the tensile design ultimate load
[1.65 MN (372 kips)].

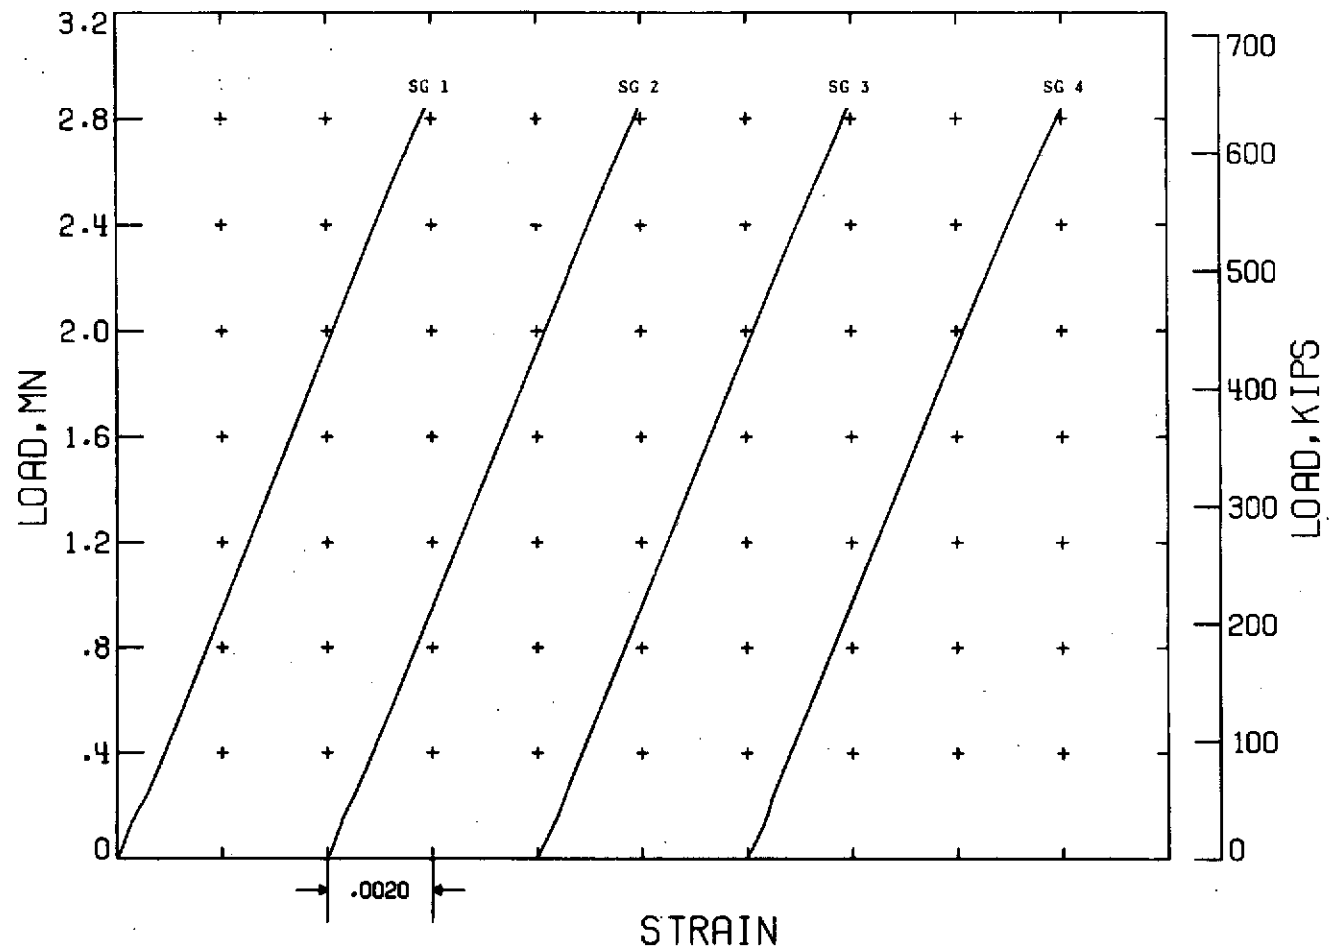
Figure 7.- Strain-gage data for the compression design ultimate load [2.83 MN (636 kips)].

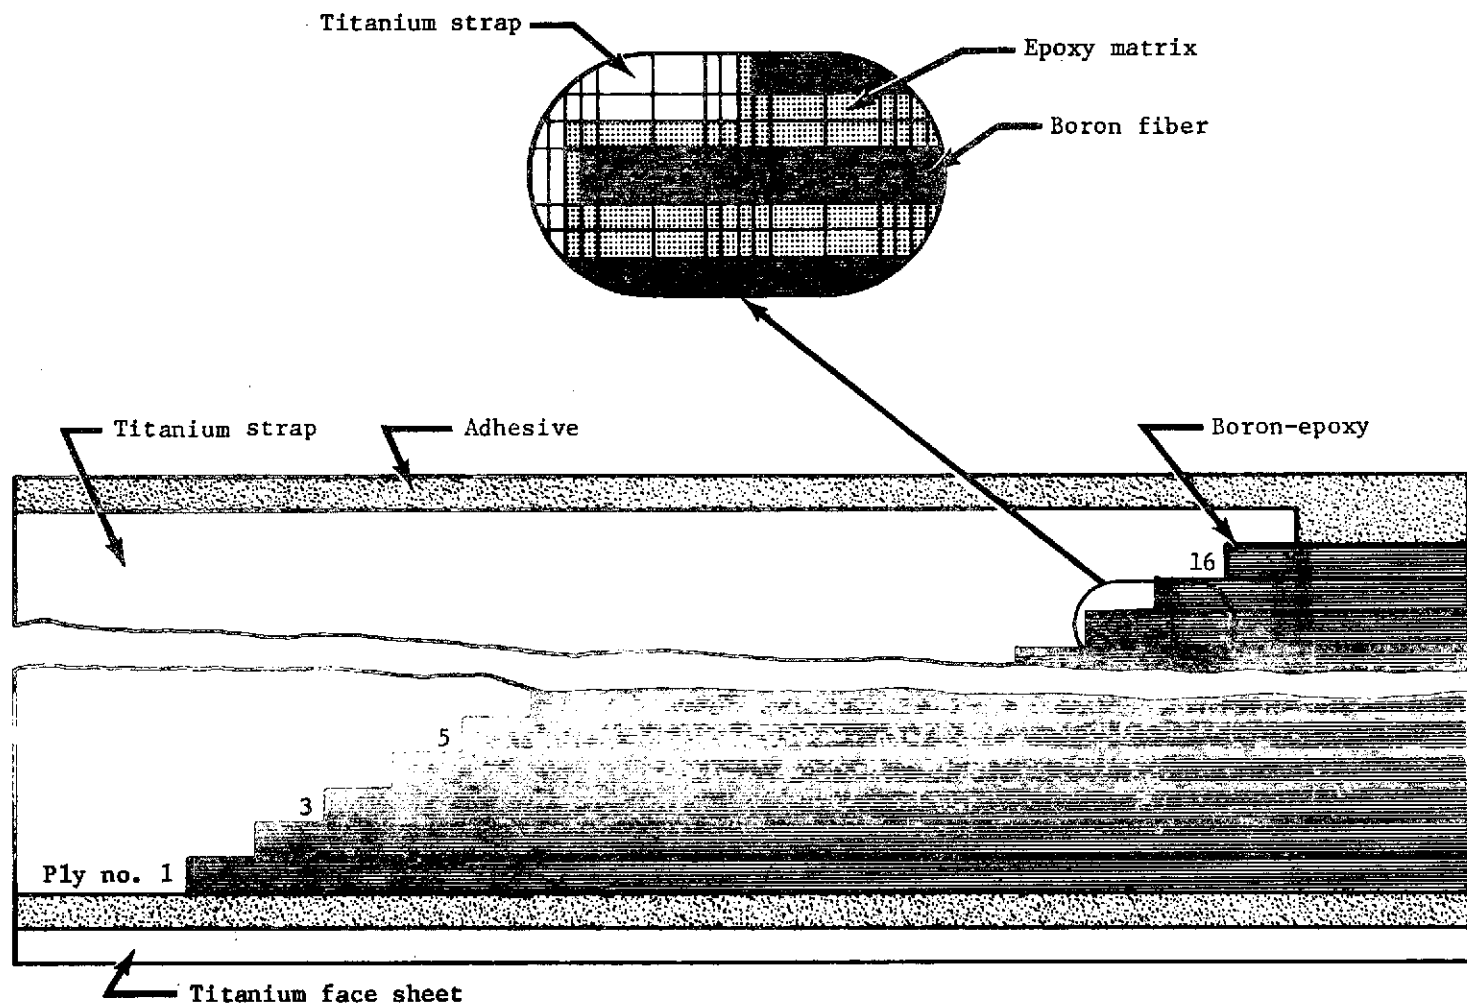
Figure 8.- Structural model used for the analytical study (NASTRAN).

The finite element model developed was that of a bonded step joint and represented a section of the drag strut bonded joint. The model included the face sheet, adhesive layer, titanium strap with 16 steps, one ply of boron-epoxy bonded to each step, and a second adhesive layer which is located between the first and second straps (fig. 8). Since each ply of boron-epoxy in the drag strut ended in a discrete step, a uniformly stepped joint was used to model the steps and the scarf portion of the titanium strap. Each ply of boron-epoxy was divided into equal volumes of boron and epoxy. The boron filament volume was assumed to be distributed in a continuous, uniform layer sandwiched between equal volumes of epoxy.

The NASTRAN program used in this study computes stresses at the centroid of each element. The boundary conditions consisted of constraining the left edge of the model (fig. 8) while a uniform displacement (calculated from strain measurements at tensile ultimate load) in the direction of the fibers was applied to the right edge of the model. The parameters computed in this study consisted of the shear, axial, and normal stresses; forces at the constrained grid points; and displacements of the grid points.

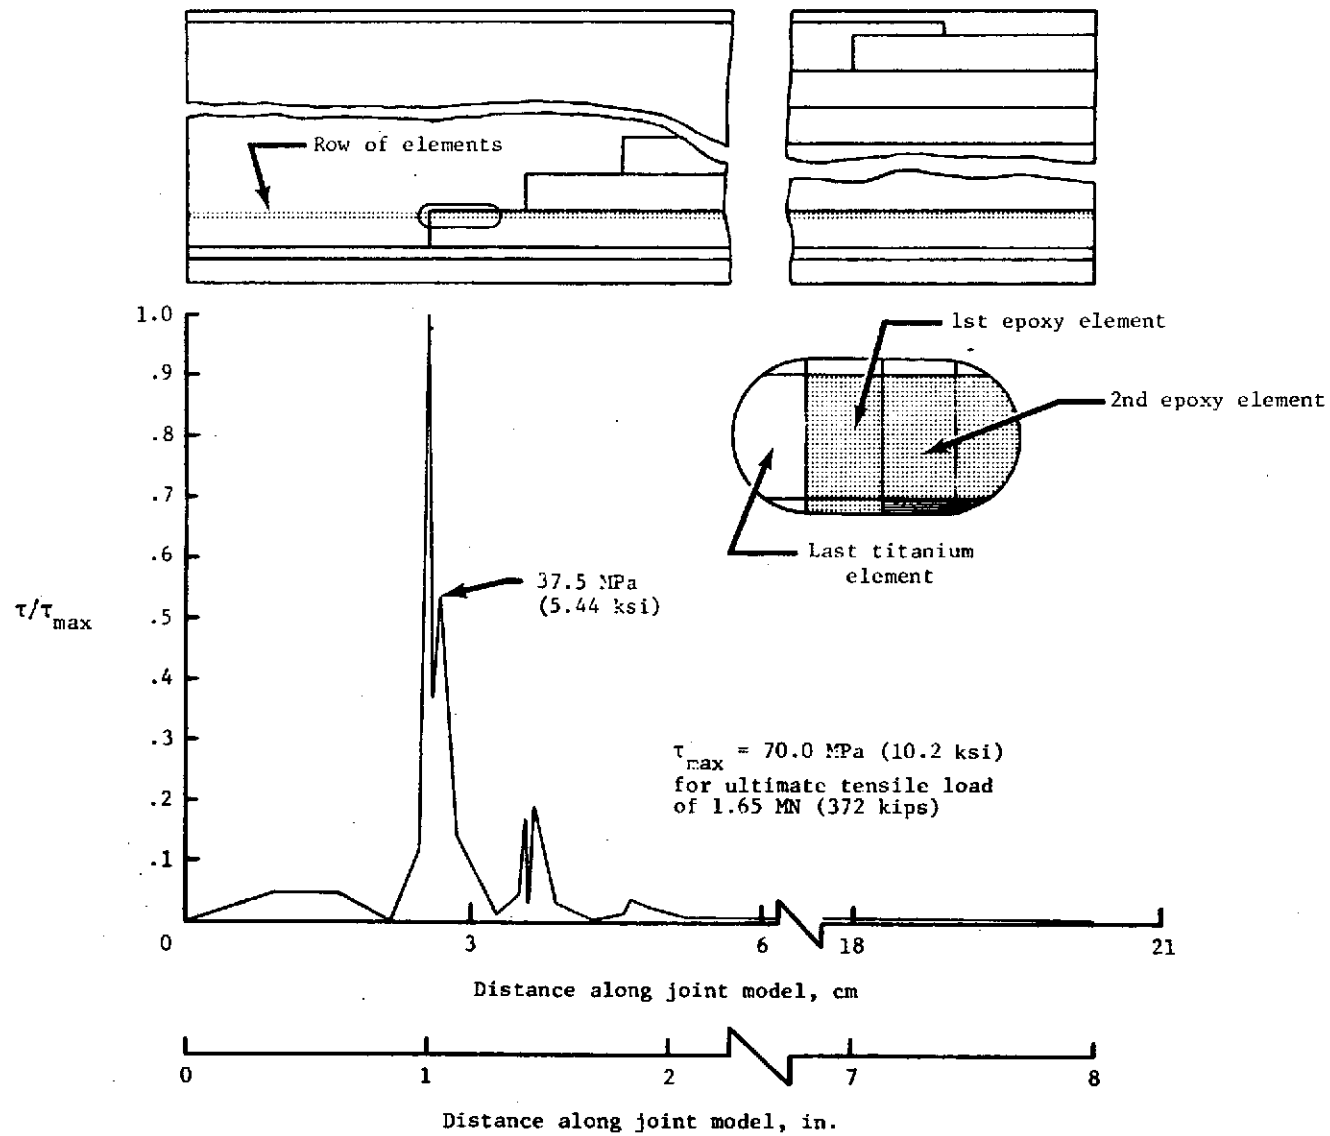
Figure 9. - Shear stress pattern of the row of elements containing epoxy matrix of the first ply of boron-epoxy.

Shear stress data obtained from the NASTRAN model are presented in figure 9 where the normalized shear stress is plotted as a function of

position along the joint model. The curve shows the shear stress pattern of the row of elements containing the upper epoxy matrix of the first ply of boron-epoxy. At the left edge of the model, in the titanium strap, the shear stress is zero. The stress remains small until the first step, at which point the peak stress [70.0 MPa (10.2 ksi)] in the titanium occurs. The next element which is the first element of epoxy has a considerably lower stress value of 26.1 MPa (3.78 ksi); but the peak matrix shear stress 37.5 MPa (5.44 ksi) occurs in the second epoxy element. This peak matrix shear stress is approximately 50 percent of the matrix material shear strength (ref. 1). The stress drops very rapidly from this point to the second step where a second pair of shear stress peaks, of considerably lower values, occur. From this point to the right edge of the joint model, the shear stress is small, essentially zero, with negligible perturbations at subsequent steps.

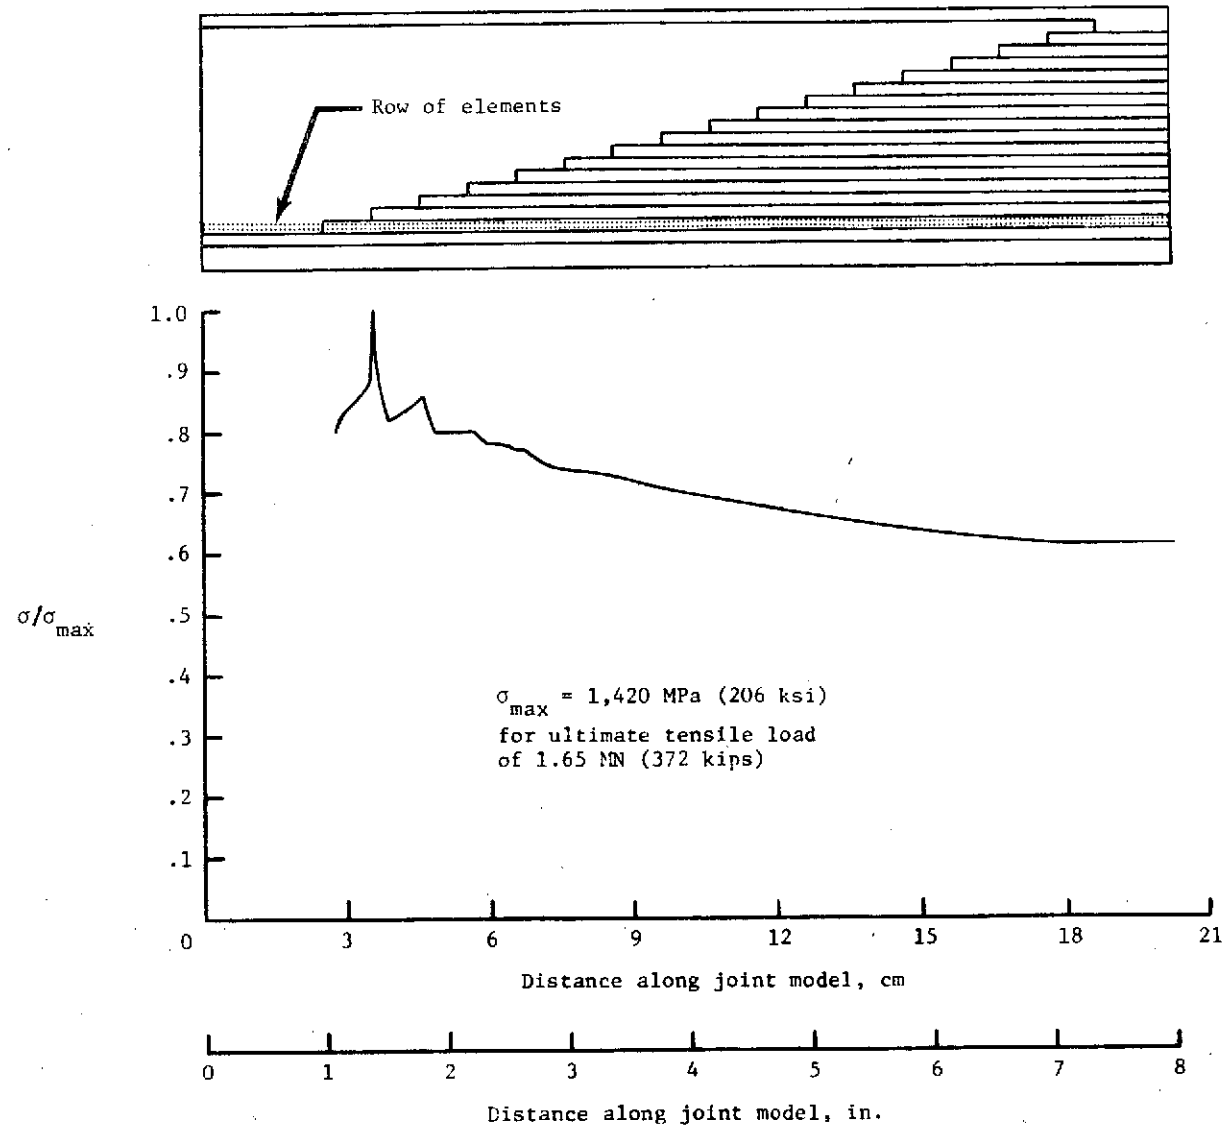
Figure 10. - Axial stress in the first ply of boron fibers.

In figure 10 the normalized axial stress of the first ply of boron is plotted as a function of distance along the model. The stress increases rapidly in the vicinity of the first step. At the second step there is an abrupt increase in the axial stress of the fiber to the maximum value of 1,420 MPa (206 ksi). This increase is caused by the decrease in effective area due to the epoxy bond at the end of the second fiber. From this point the stress continually decreases, with progressively decreasing perturbations at the successive steps, until the end of the titanium strap is passed. From the end of the strap to the end of the model there are no further changes in configuration and the axial stress is constant at 0.62 times the peak stress. This figure clearly shows

where the maximum stress occurs in the boron fiber and aids in understanding the axial stress profile of an individual ply in a bonded step joint.

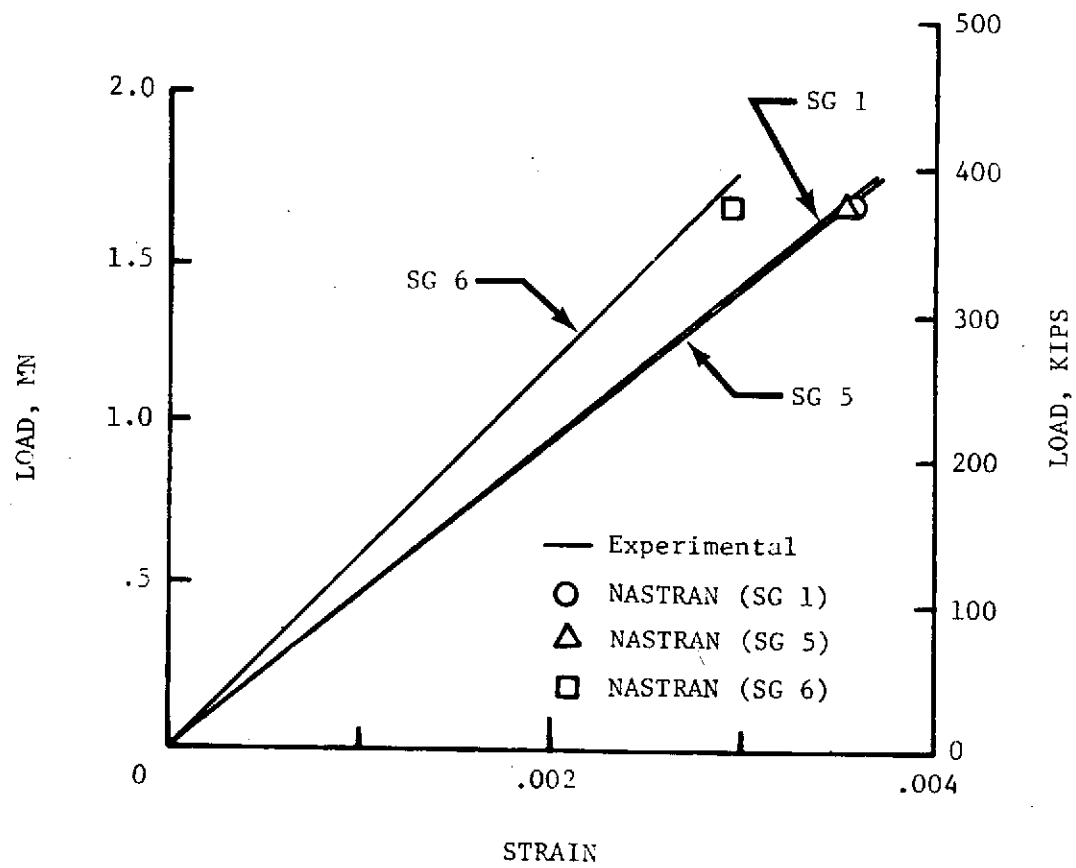
Figure 11. - Comparison of experimentally and analytically determined strains.

In order to verify the analytical study of the joint, computed strains were compared to experimental values. This comparison is presented in figure 11 where the applied load is plotted as a function of the measured strain. The solid lines are the experimental data obtained from strain gages during static loading to the tensile design ultimate load [1.65 MN (372 kips)]. The symbols represent computed values of strain at model locations that correspond to the specified strain gage locations. At the tensile design ultimate load, the agreement is excellent at the all-titanium area (gage 5), at the first ply of boron-epoxy (gage 1), and at the area beyond the joint in the all-boron-epoxy area (gage 6). This figure shows that the NASTRAN finite element analysis is a viable tool for predicting stresses and strains in a bonded step joint at the working stress levels.
